Magnetic Locking Devices Detaching and Falling (Health & Safety Alert)

Date: October 2018

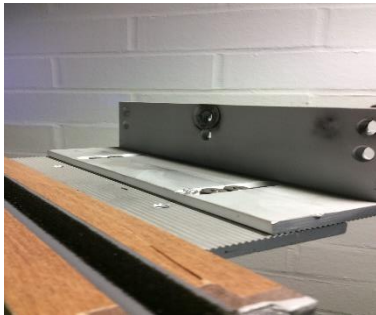
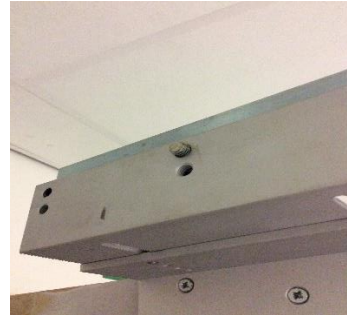
A magnetic door locking bracket became detached from its fixing and collided with a student. The potential for a serious injury was significant.

The type of bracket is illustrated below:

Over time the bolts on the threaded lock screw had come off and the screw worked its way loose causing the plate to detach from the bracket.

The security and stability of devices such as this must form part of regular door inspections.

Immediate inspection should take place of all devices and remedial actions taken where appropriate.
